LOCARCH SHELTER

Jean R. Saulnier, et al

Air Force Civil Engineering Center
Tyndall Air Force Base, Florida

May 1975

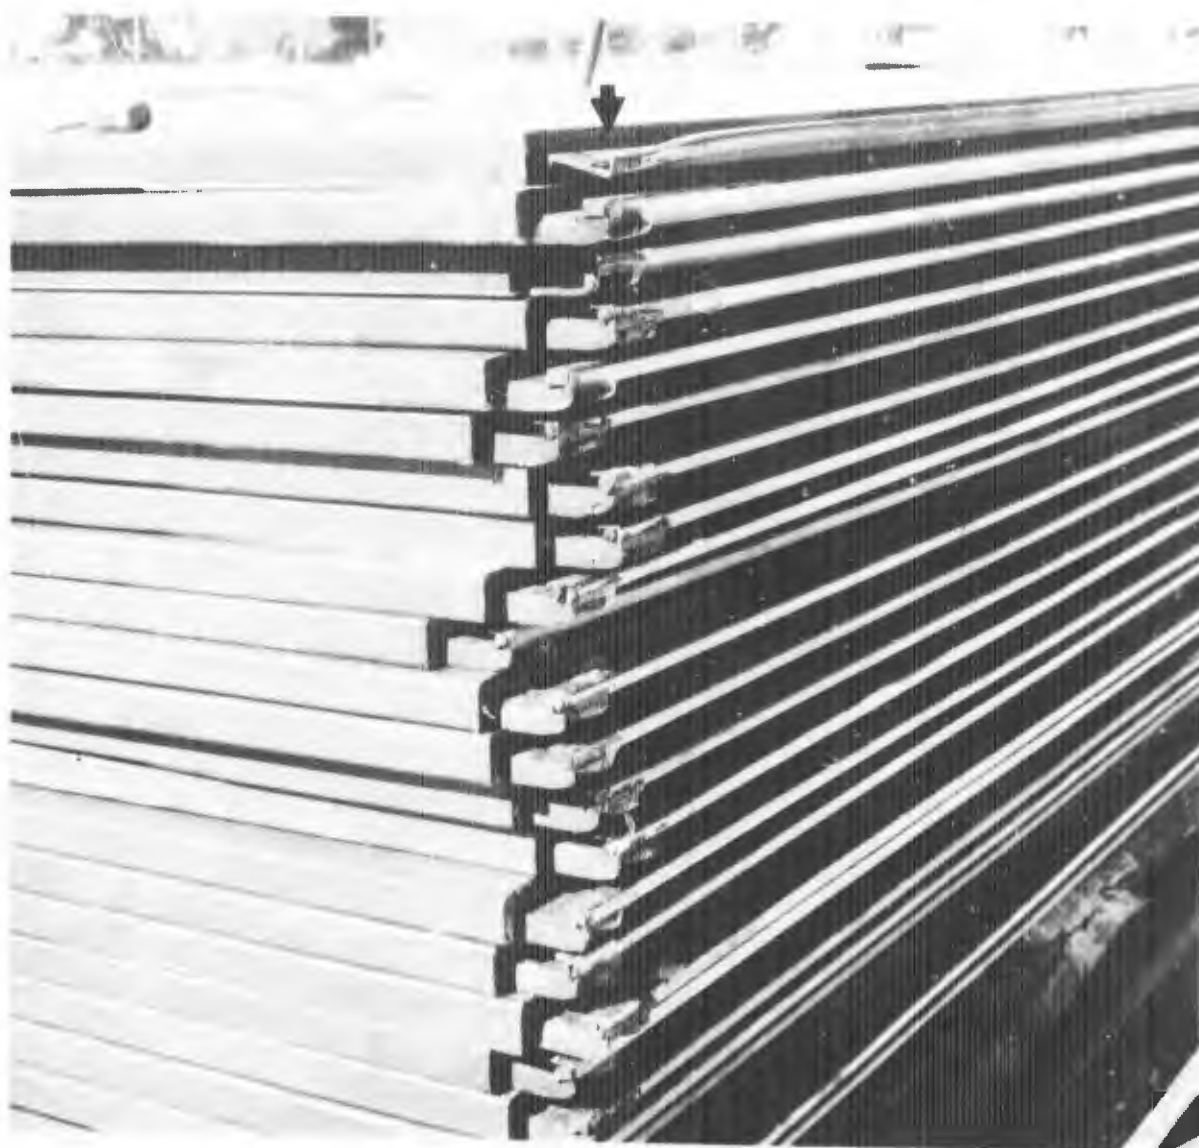
Figure 13 shows the arch panels as they were received from the contractor. Some minor damage was experienced during shipment as indicated on the top panel of the pallet. This was easily corrected by means of a screwdriver that was inserted in the aluminum extrusion and the aluminum extrusion bent back to shape.

Figure 13 Arch Panels as Received From the Contractor

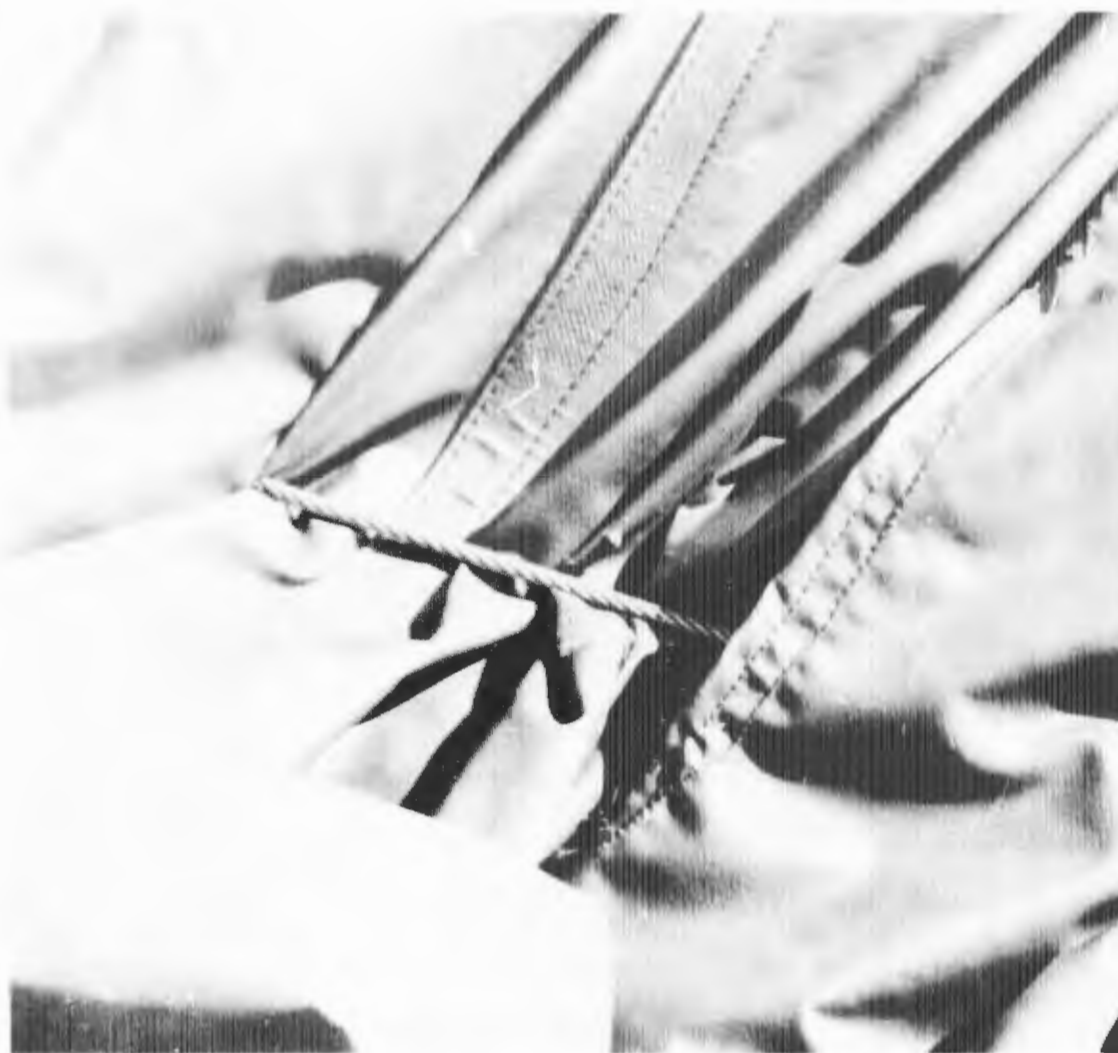
Figure 45 Cable Rubbing on Fabric as Door is Opened

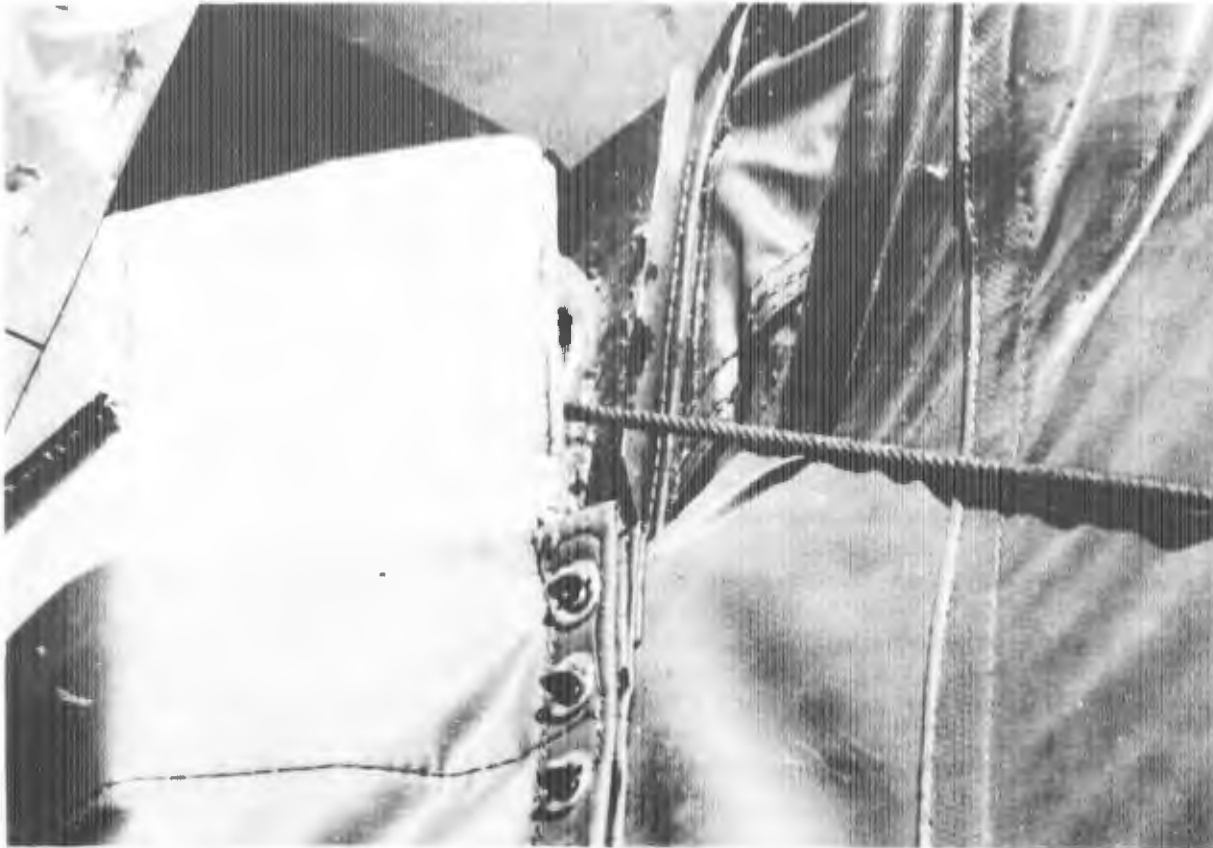
Figure 47 shows where the cable passes through the uppermost part of the nonpivoting vertical support posts and then down to the winch. Considerable wear was experienced at this point both on the aluminum and the fabric material.

(Figure 47 Cable Wear Experienced at Vertical Support Post entry into the shelter. As previously described for the purposes of this test program, only one container was provided in the contract to provide testing of the proposed system. The side closures for the end wall consisted basically of a fabric material between the arch beam and the vertical support beam that was hooked to the container. The attachment method was by use of a rail similar to that used on the panel to panel connection. This was bolted onto the exterior of the container and the arch beam and then a similar rail was attached to the edge of the fabric and locked the fabric transition from the shelter

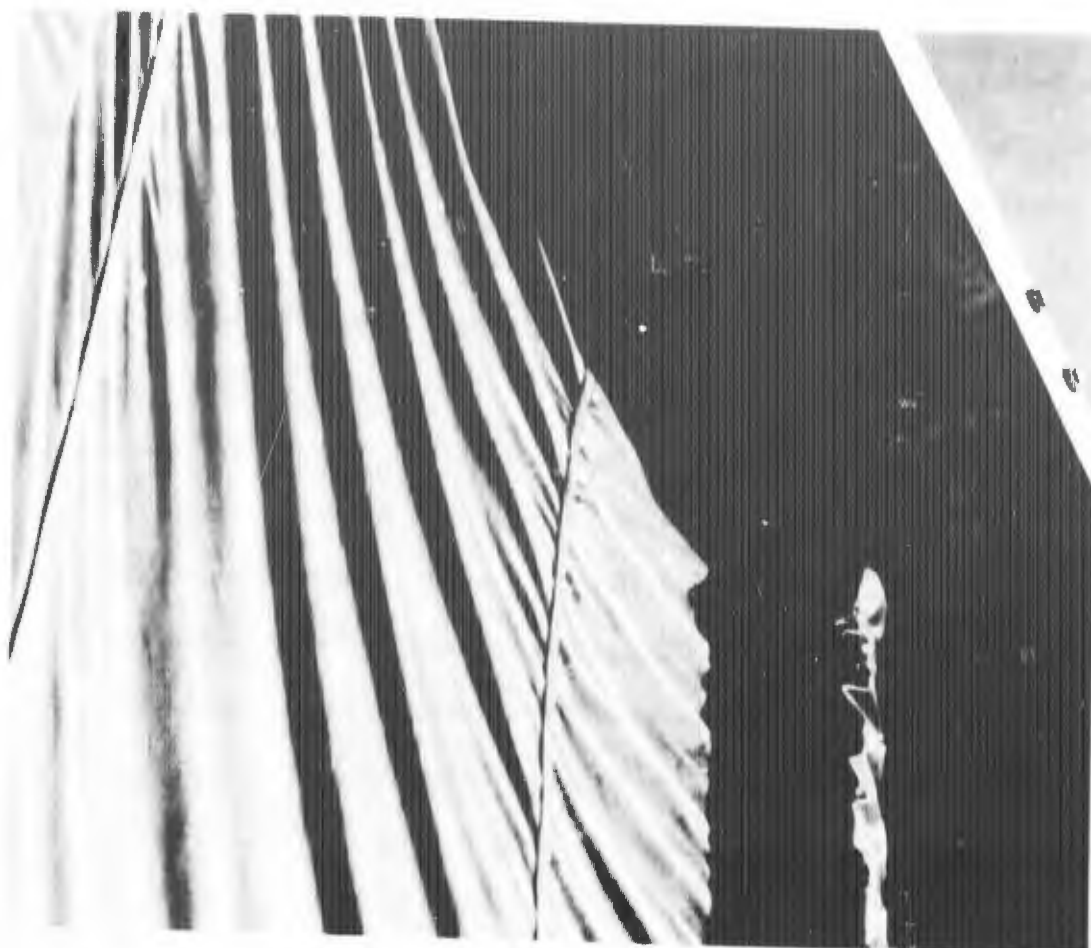
Figure 48 Vertical Support Beam Separated From Arch Beam on the door from blowing wind. The vertical support post is held on the beam with a nut that is screwed onto the erection pin. This problem could easily be overcome with the insertion of a cotter-pin behind the nut to hold it securely in place.

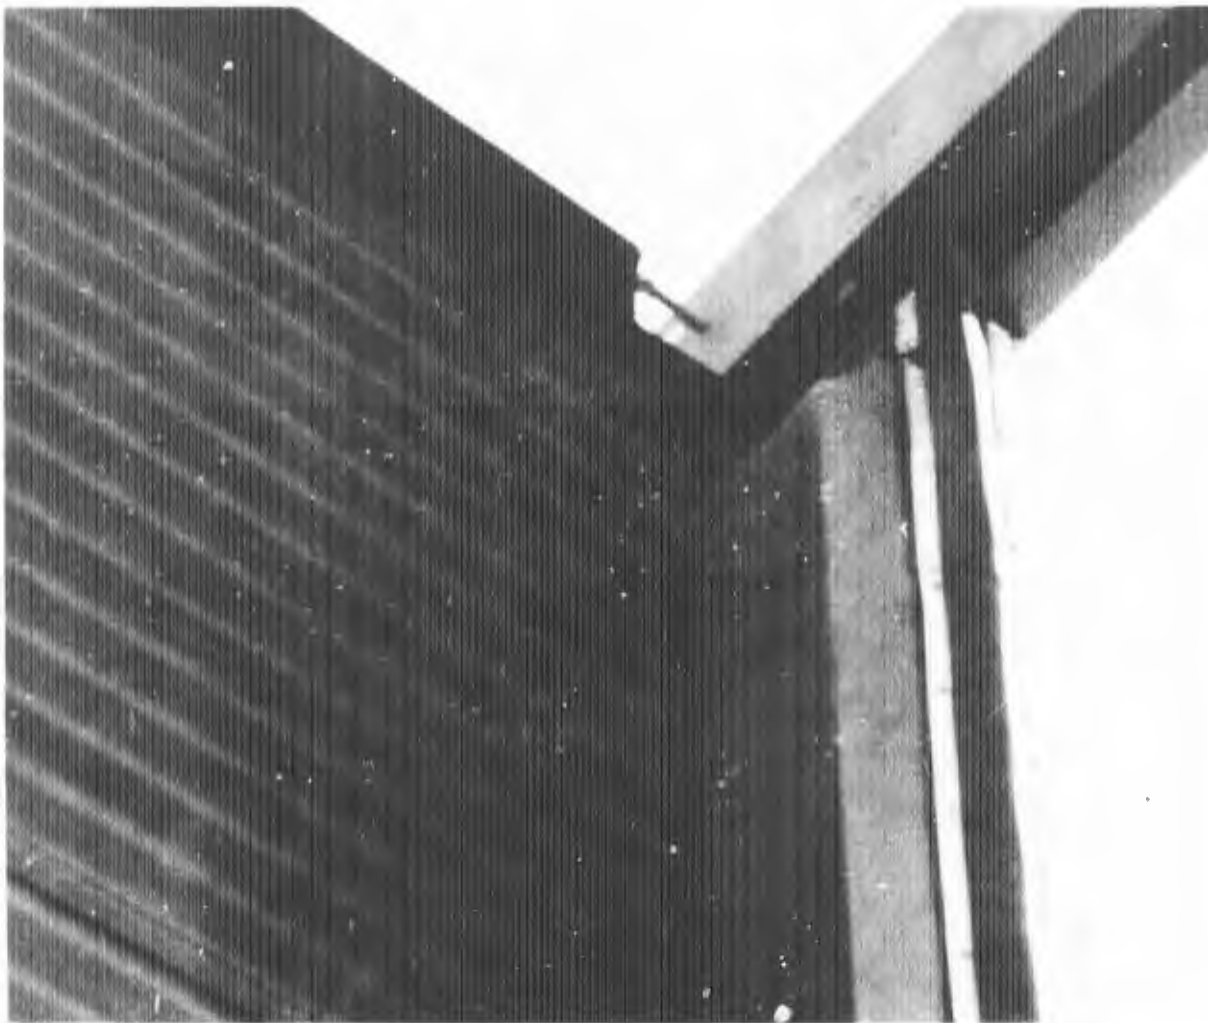
due to the ground elevation. This caused the upper trolley rail to be unlevel. As the personnel tried to open the door, it bound in the upper trolley rail. The keeper release ropes were used to pull the upper portion of the door laterally as it rides in the rail and physical force is used at the bottom. Figure 53 shows the vertical beam inside the trolley rail. When the beams started to twist,

Figure 53 Vertical Beam Binding in Upper Trolley Rail,
Metal Door

it bound inside the rail and had to be released by either pulling the door back toward the closed position or using a piece of equipment to get up high enough to force its release. Figures 54 and 55 show both sides of the metal door in full open position. When both sections are

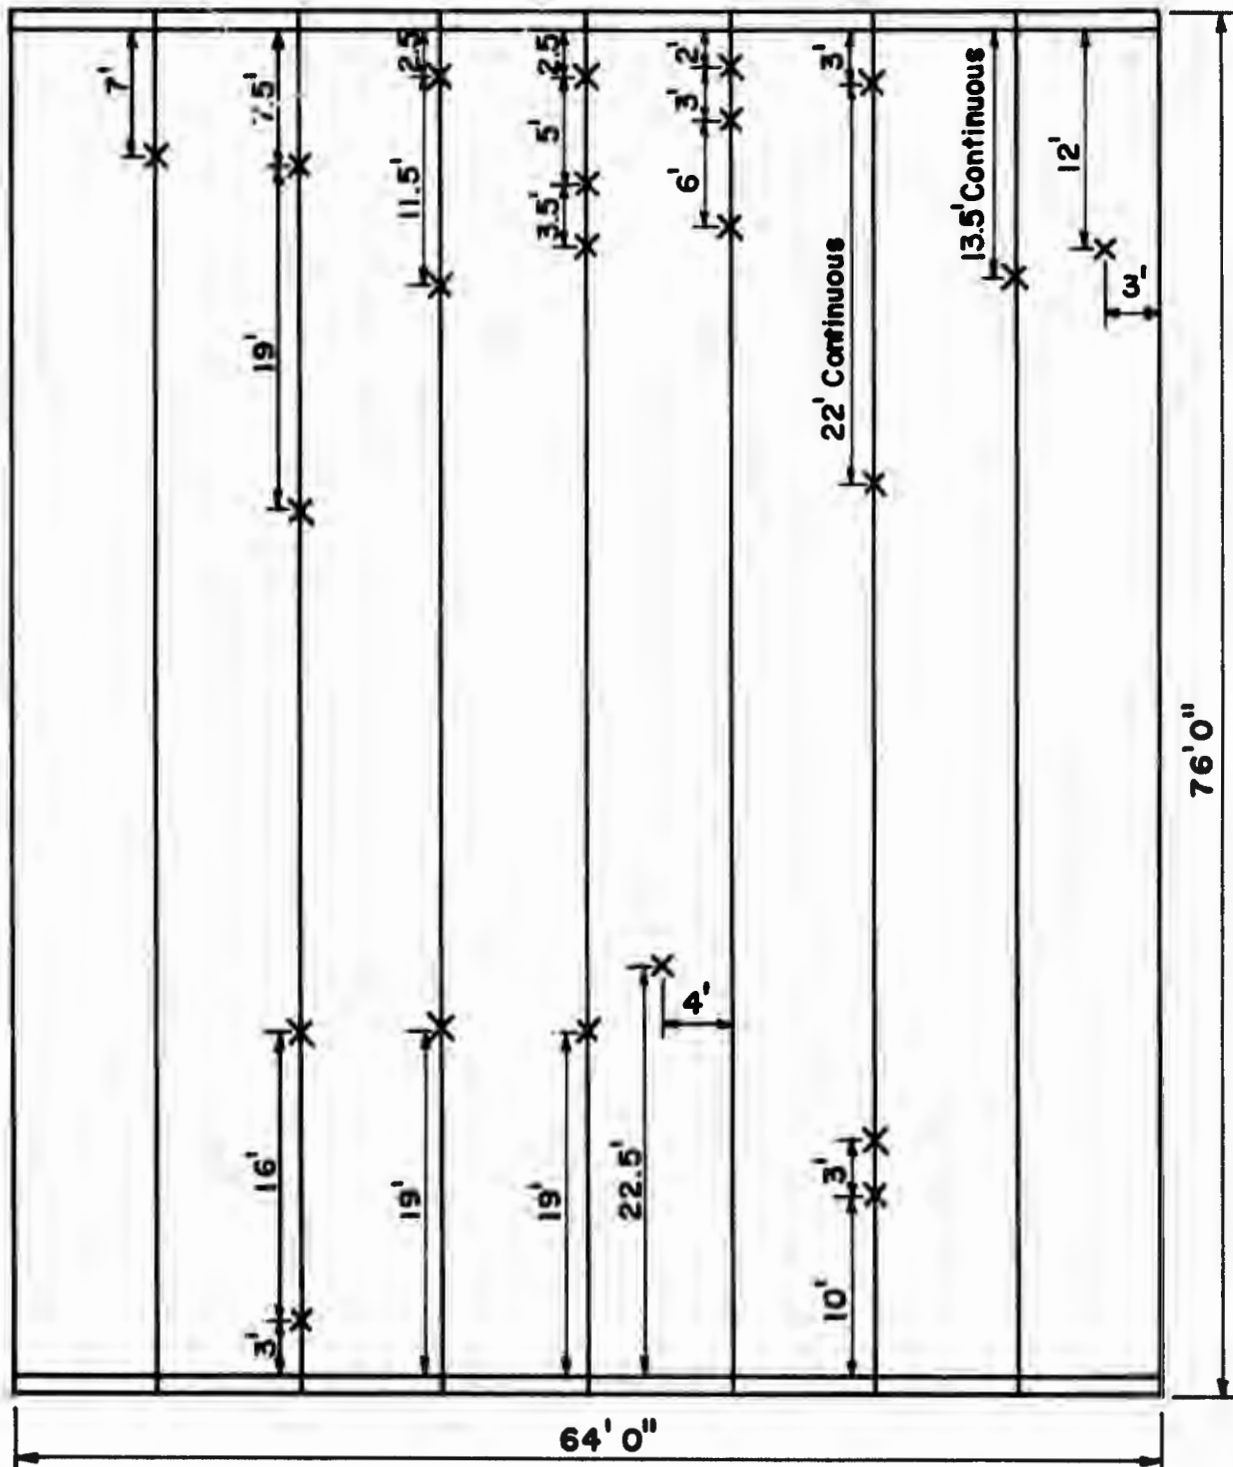
4. Water and Wind Test. Approximately two weeks after the building was first erected and before any water tests were carried out, the building experienced a heavy rainfall. Many leaks were noted throughout the structure, particularly near the perimeters of the building. It was discovered that some slack had come into the panels; therefore, all the archs were retensioned. After they were tightened, some of the leaking did stop but not completely (Figure 58). Only one leak was noted in the panel to panel connection. Water testing on the shelter after the first erection was primarily carried out with the use of a fire hose. Personnel conducted the test on different areas around the building and by applying water to the various components to ascertain if any specific areas were vulnerable to the leakage. Water testing with the fire hose then proceeded to observe if the structure inherently leaked or erection deficiencies resulted in the leaking. Spraying water on the top of the building and letting it free fall on the top created a buildup of water running off and down the sides. As this water ran down over the panels, a great deal of water also entered the arch beam, which was, of course, the drain. As the water accumulated in the arch beams, water was noticed splashing out of the arch beams at the beam connections and also carrying over the arch beam and down the side of the beam. This problem was

Figure 58 Water Leakage Points After Rainfall

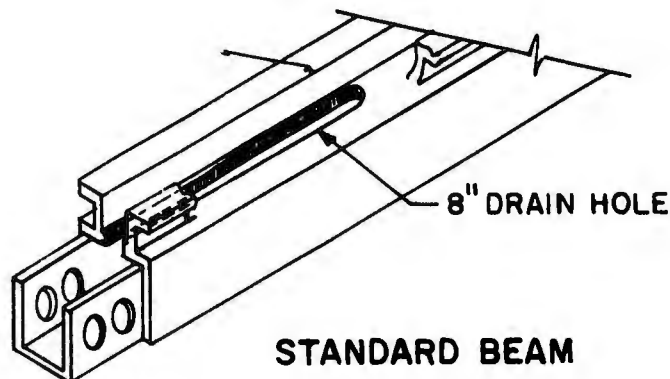
Figure 59 End of a Typical Arch Beam With Cutout For Water to Enter Beams

beams at the two lower areas by cutting out an additional piece of aluminum to enlarge the hole and thereby allow more water to fall into the arch beam. This modification was made only on four beam sections and would be required throughout the whole building in order for all arch beam segments to be interchangeable. This modification did resolve some of the problem, but it was evident that water was still coming in the building at the track on the arch beam where the panel insert did not completely enclose it. Another problem that was noted was that it made a difference on which side of the shelter the water was allowed to run down at the panel to panel connection. The locking joint on the panel, if it were overlapping down, carried

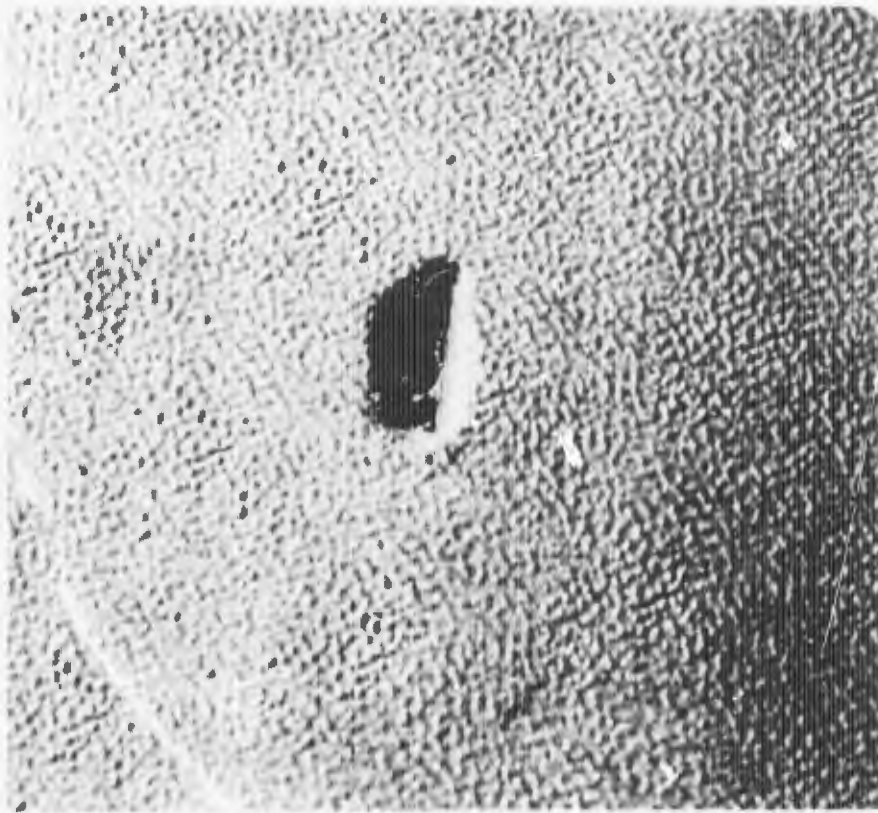
Figure 69 Puncture (approx $\frac{1}{2}$ in) in Panel Skin With Honeycomb Core Exposed

in the vertical position for the drop and when it impacted the ground on the edge it fell over on a small rock. The weight of the panel falling on the rock on the concrete surface penetrated the .017 inch thick aluminum skin without any difficulty. This was noticeable throughout the test phase of dropping panels on the concrete. A surface puncture such as this would allow the water to migrate inside the panel and render it useless in a short time. If the panels were handled carefully through the erection process, no damage resulted. Under field conditions, one can assume somewhat rougher handling than the panels experienced during the test. The thin aluminum skin, the edge members and panel inserts would most likely undergo a great deal of damage during the life of a shelter.

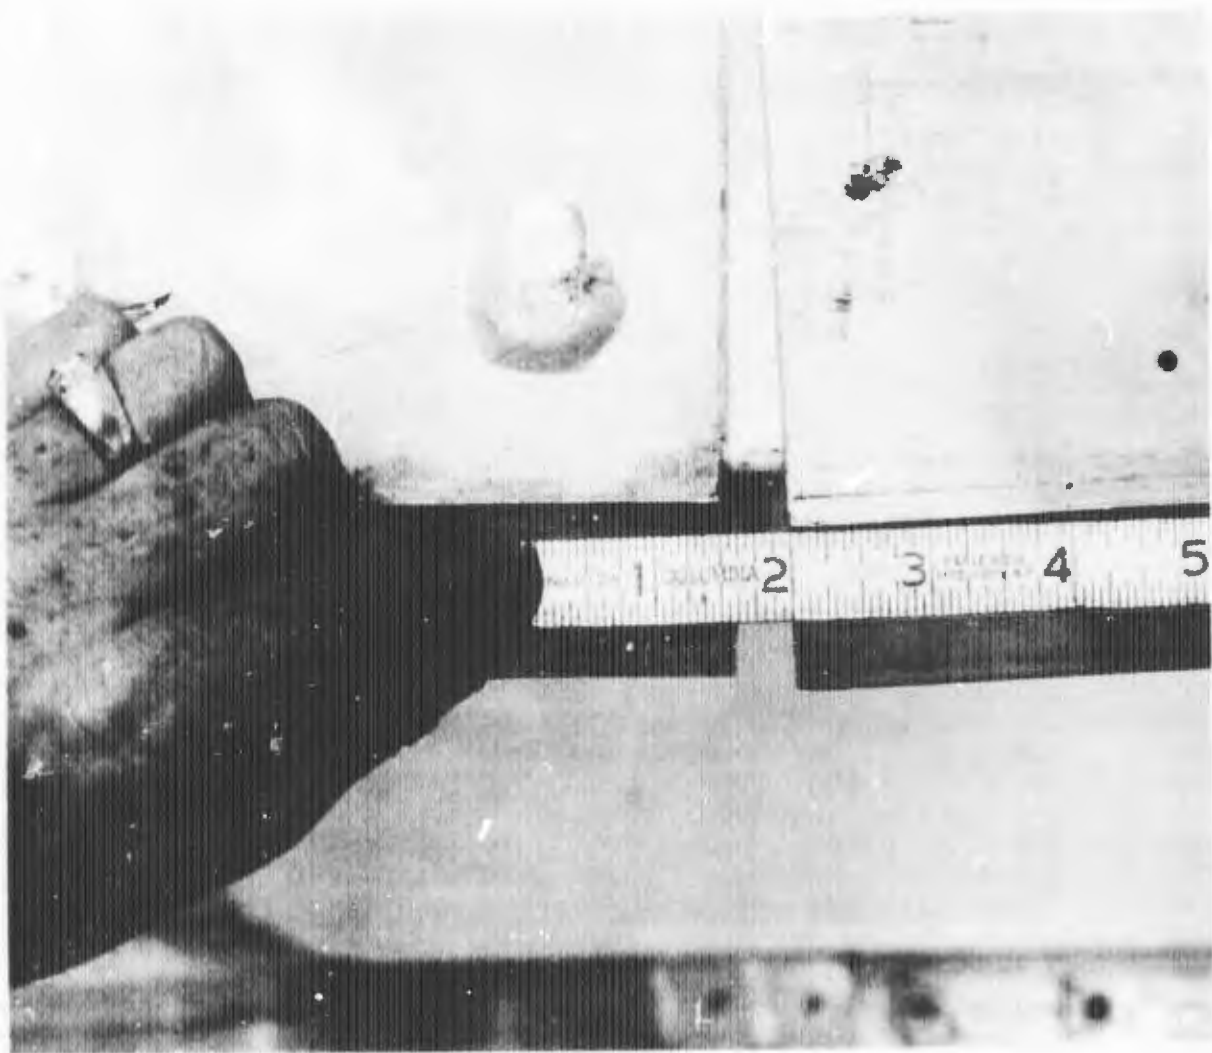
shelter with the sandbags in place. It was somewhat surprising to see the shelter absorb as much deflection without any apparent failure. Figure 77 shows the center segment of the 5th arch beam, the area under the heaviest load. The weight of the sandbags had caused the beam to deflect to such a degree that $\frac{1}{2}$ inch space occurred where the bayonet slotted into the preceeding beam. Before the loading of the sandbags, the joint had no separation in the area. It was also observed that the erection pins at this particular joint became oval, rather than their original round shape. Figure 78 is

Figure 77 Joint at Center Arch Beam

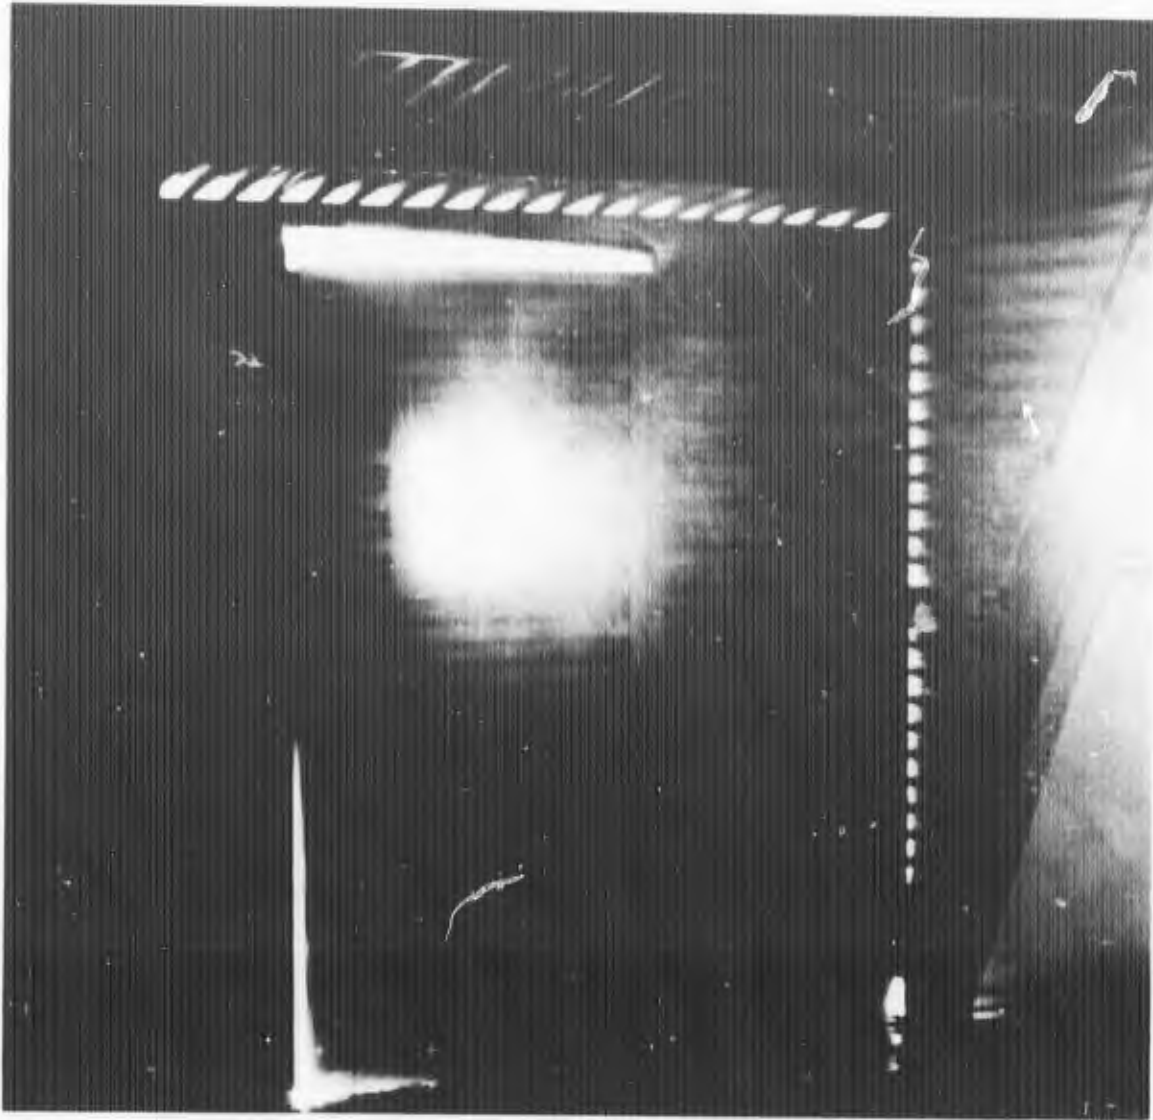
Figure 92 Water Entry on Side Door System

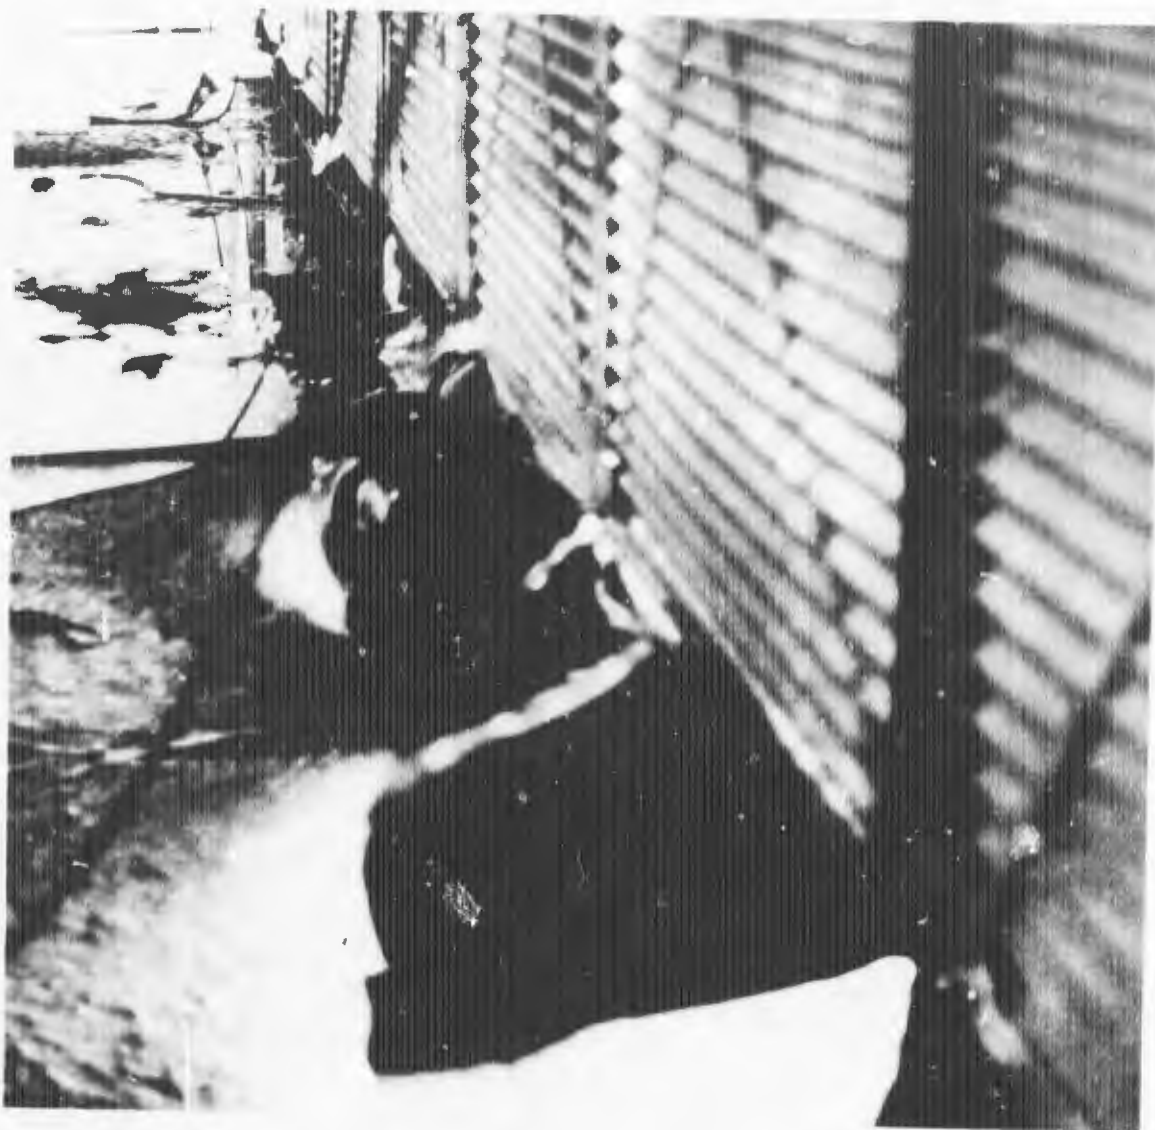
Figure 95 Water Leakage Under Metal Door and Ground Skirt
Being Blown Inward
